# SEISMIC ASSESSMENT AND RETROFIT STRATEGIES FOR 16TH-CENTURY HISTORICAL STRUCTURES IN NORTHERN INDIA

## Abstract:

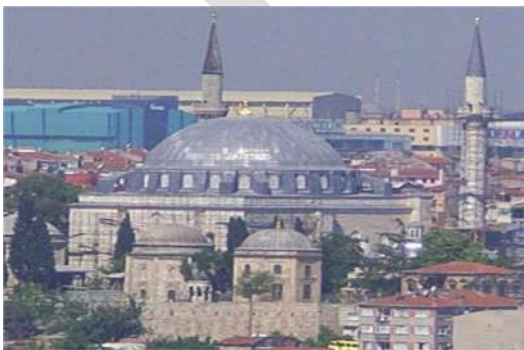
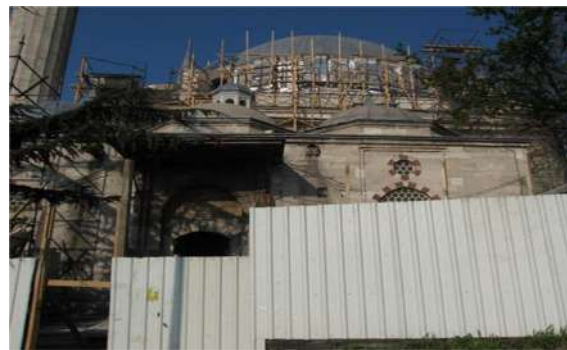
**Figure 1 The Yavuz Selim Mosque under restoration**

The Yavuz Selim Mosque, an Ottoman imperial mosque completed in 1522, stands atop the 5th Hill of Istanbul, overlooking the Golden Horn (Figures 1a, b). It is the second oldest existing imperial mosque in Istanbul. Although the architect remains unknown, some have tried to link it to the renowned imperial architect Mimar Sinan, but no documentary evidence supports this claim. The mosque features a large courtyard with a colonnaded portico, boasting columns of marble and granite from various regional quarries. The mosque is adorned with early examples of distinctive Iznik tiles and flanked by twin minarets. Currently, it is undergoing restoration and is scheduled to reopen in 2009. This context of historical architectural significance parallels the study of Seismic Assessment and Retrofit Strategies for 16th-Century Historical Structures in Northern India.
